# **Trip Report**

## **2001 Annual Inspection and Radiological Survey of the Piqua Nuclear Power Facility, Piqua, Ohio, Decommissioned Reactor Site**

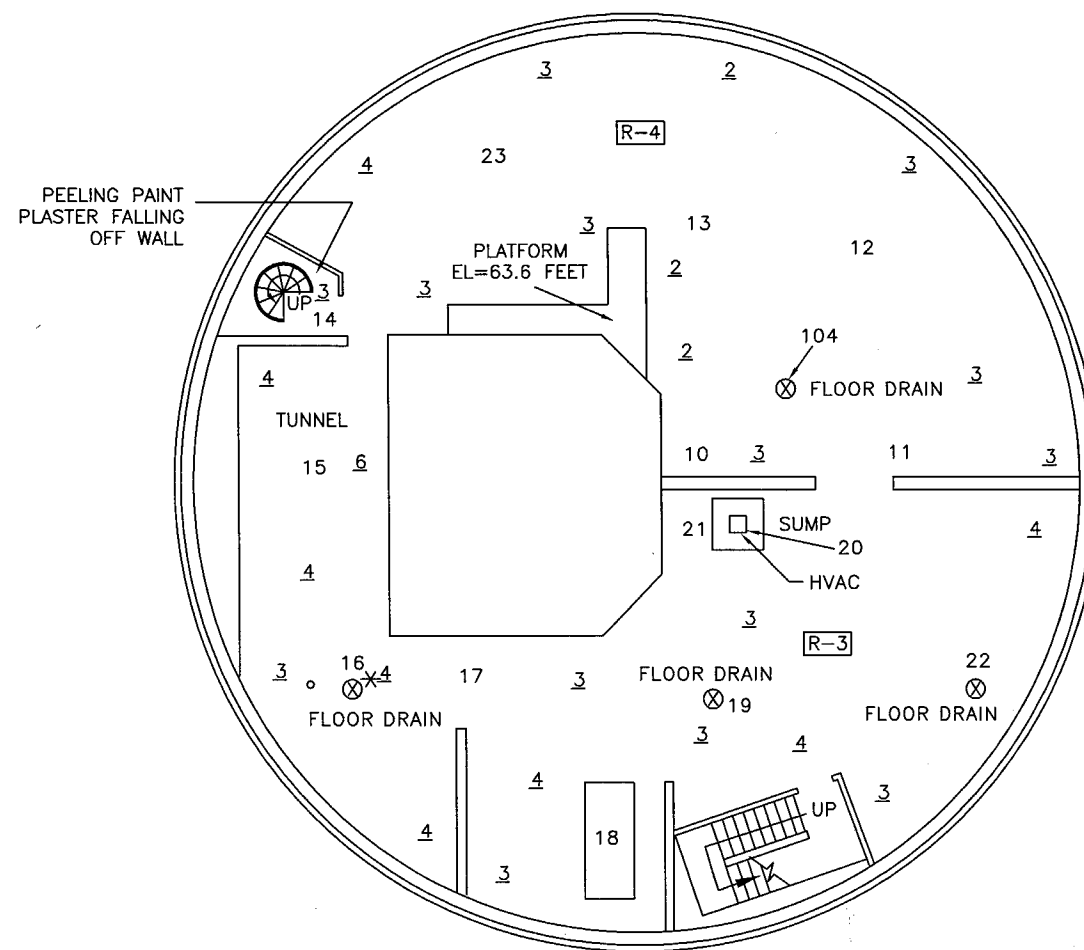
PLAN - 56 FOOT LEVEL

Table 2 presents surface and removable activity results. No removable contamination was found. One sample point, the floor drain at the lowest level of the containment building, exhibited a direct beta reading of 11,440 disintegrations per minute per 100 square centimeters. This result is consistent with previous surveys. Most other readings were below the minimum detectable activity (MDA) level. The few readings that were above the MDA are attributed to statistical counting anomalies in the measurement of the smears taken to detect removable contamination.
